MISCELLANEOUS PAPER S-68-13

**MEMBRANE - ENVELOPE TECHNIQUE FOR
WATERPROOFING SOIL BASE COURSES
FOR AIRSTRIPS
BARE BASE SUPPORT**

July 1968

Conducted by
**U. S. Army Engineer Waterways Experiment Station
CORPS OF ENGINEERS
Vicksburg, Mississippi**

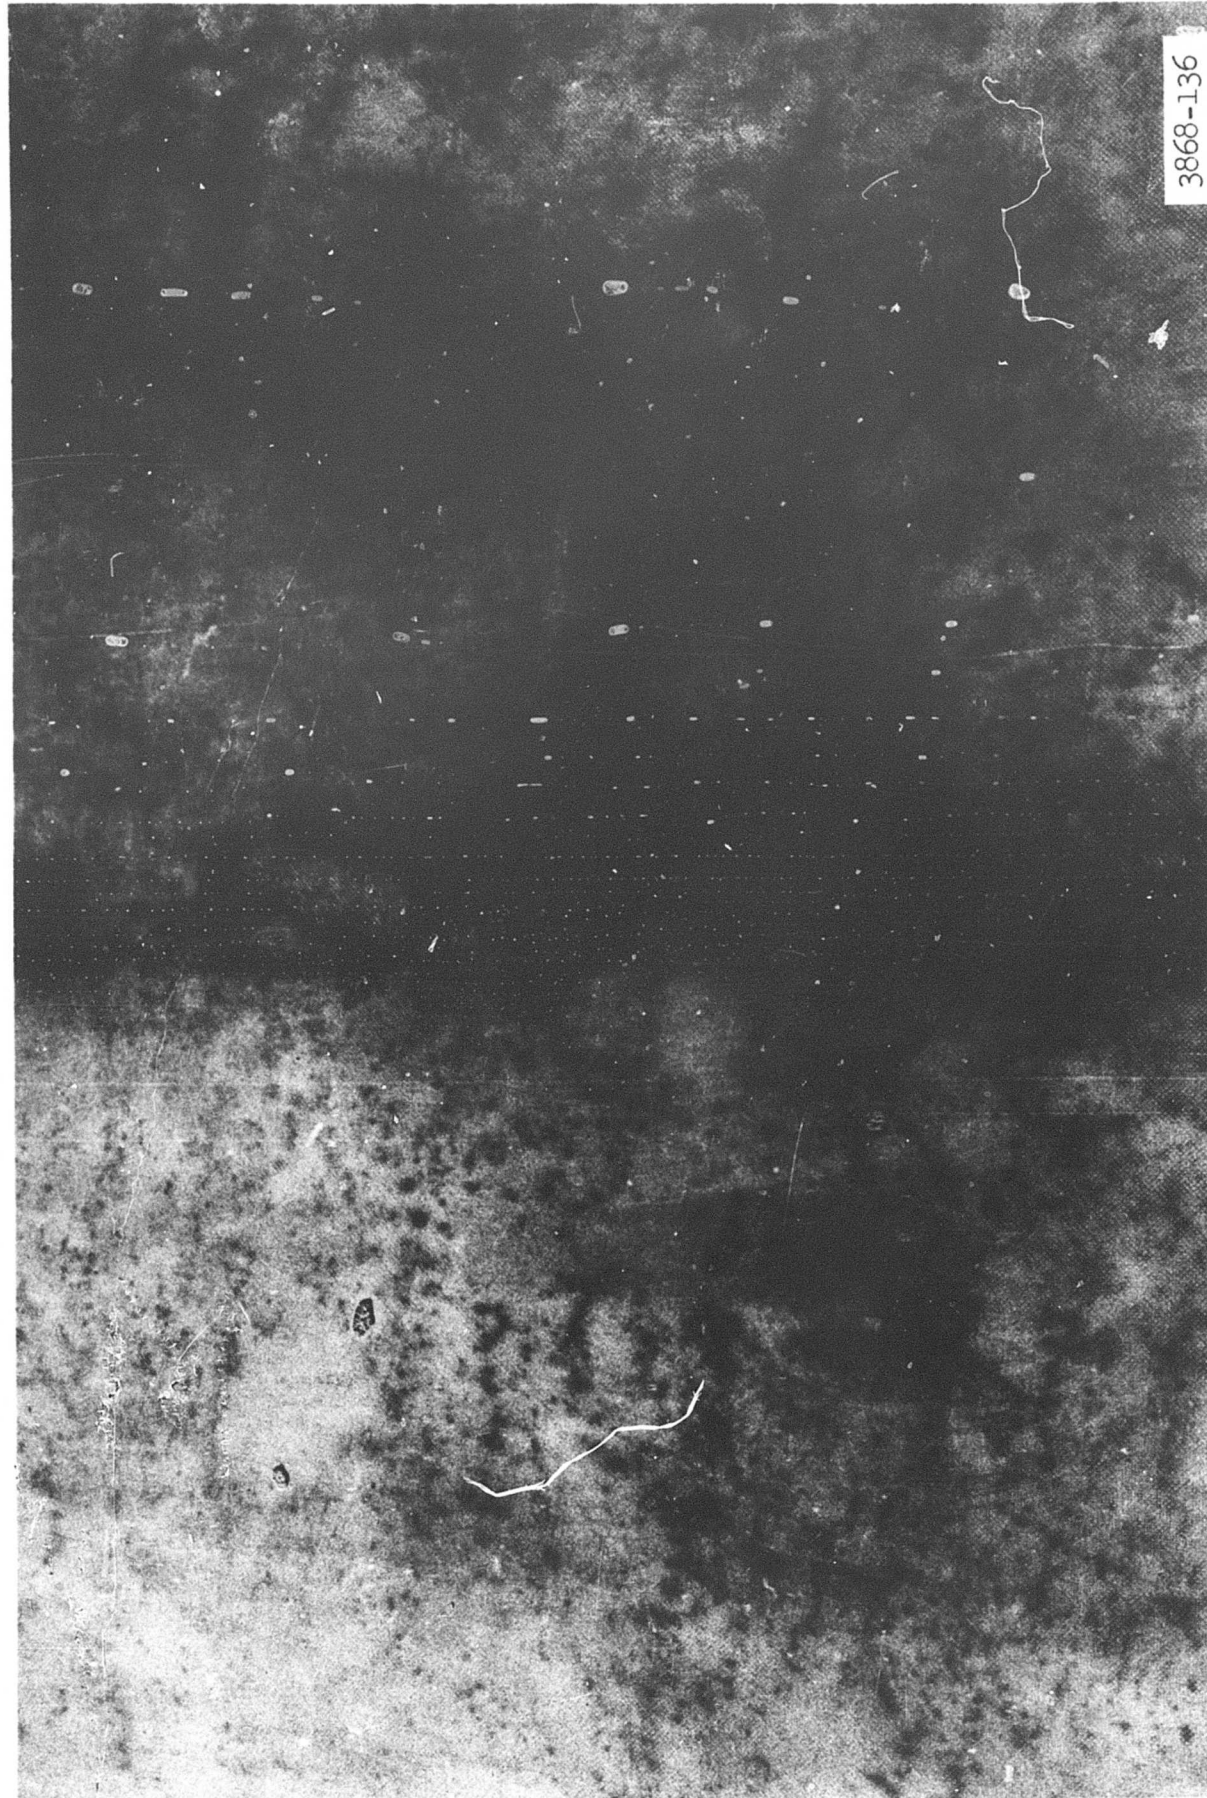
68. An analysis of the relative performance of the T16, T17, and WX18 membranes showed that the best service was obtained with the T16 and WX18. The T17 was not entirely satisfactory due to excessive failure of the factory-fabricated longitudinal joints. Since all three membranes are constructed of neoprene-coated nylon and differ only in weight and ply, it follows that the best service should be obtained with the WX18. In fact, in a recently completed comparison study in which both T16 and WX18 membranes were subjected to locked-wheel skid and short-radius turn tests using equivalent F-4C loadings, the WX18 membrane withstood the severe abrasions and tearing action of the skid and turn tests, whereas the T16 membrane failed.* In the same study, DBST over T1 membrane was also subjected to locked-wheel skid tests using equivalent F-4C loadings; however, both the DBST and T1 failed completely. Therefore, the WX18 is considered to be the superior membrane for use in areas on a runway or taxiway that are likely to be subjected to severe tire abrasion.

Photograph 32. Worn Tl6 membrane

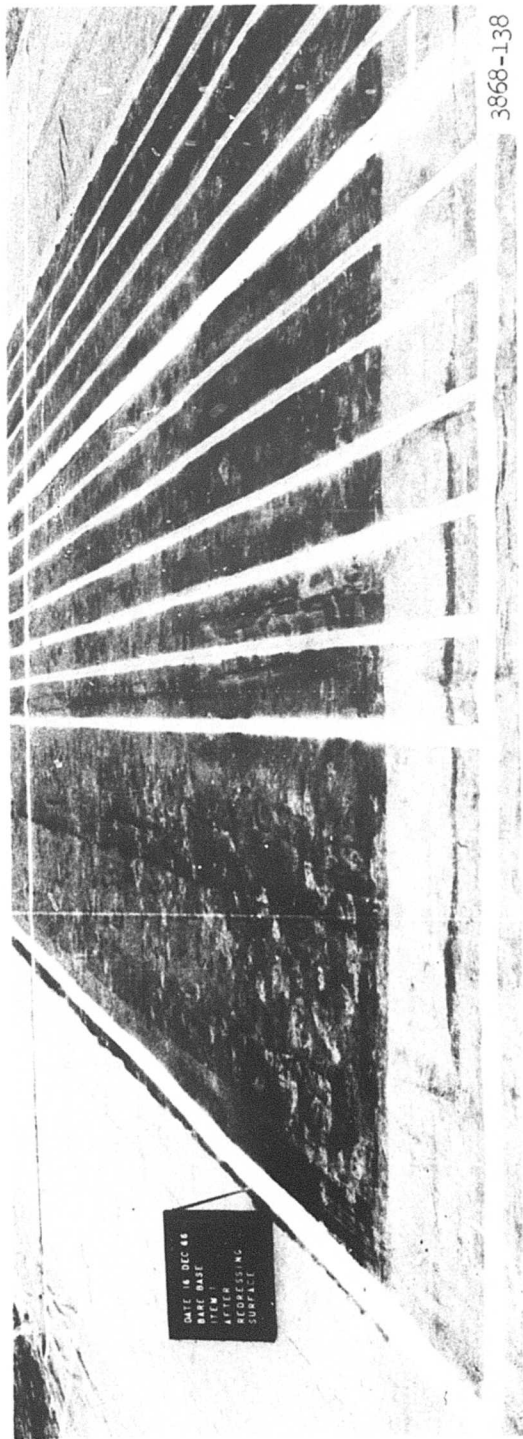
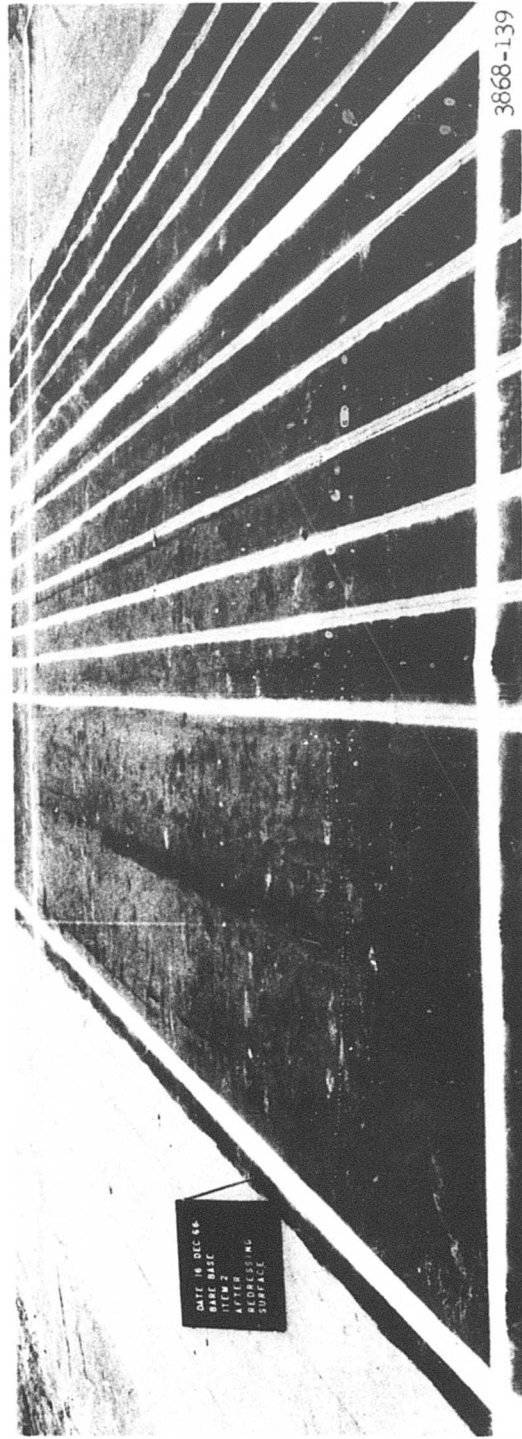
Photograph 33. Items 1 and 2 after base had been refinished at 400 coverages

Photograph 34. Items 3 and 4 after base had been refinished at 400 coverages

Photograph 35. Items 5 and 6 after base had been refinished at 400 coverages. Surface membrane is WX18

57. The T1 membrane was then placed on items 1 and 2, the T16 membrane on items 3 and 4, and the T17 membrane in items 5 and 6 was replaced with new WX18 membrane. After all membrane had been placed and sealed, the T1 and T16 were painted with a coat of black enamel paint. On both membranes, the continuous trafficking had resulted in the wearing away of the plastic material, i.e. vinyl and neoprene, on the top surface of the membrane, thereby exposing the internal fabric in several areas as indicated in photograph 32. Although no evidence of leakage through these worn areas was found, it was decided that prolonged exposure to sunlight could possibly weaken the cord and render the membrane susceptible of leakage. All work was completed on 15 December. Views of each item after the base had been refinished are shown in photographs 33-35.
